Deficiency Report

Subject Property

12345 Report St.

Observation Report

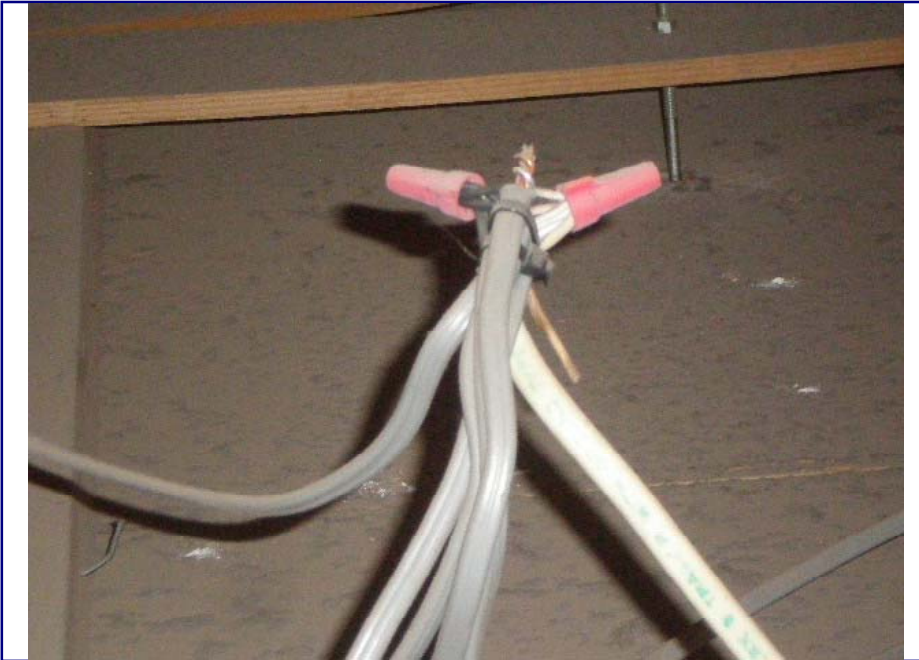
Picture 1

Exposed splices/
unprofessional wiring noted in
the attic area, recommend
electrician evaluate/ repair all
wiring in attic area to help
ensure proper, safe
operation.(2)(4)

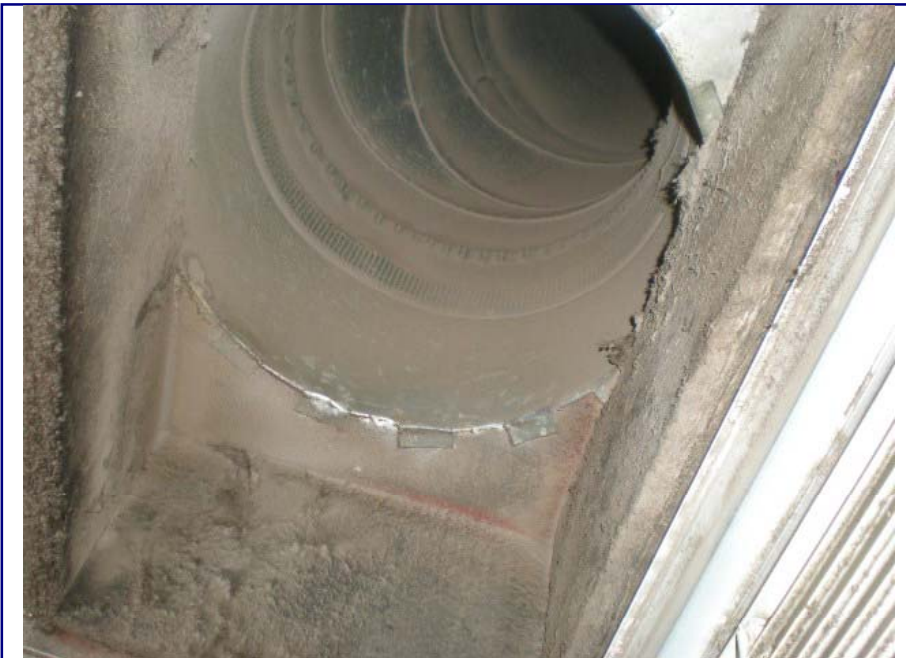
Picture 2

HVAC filter was missing at the
time of inspection, recommend
cleaning/ servicing system to
help ensure proper, efficient
operation.(2)

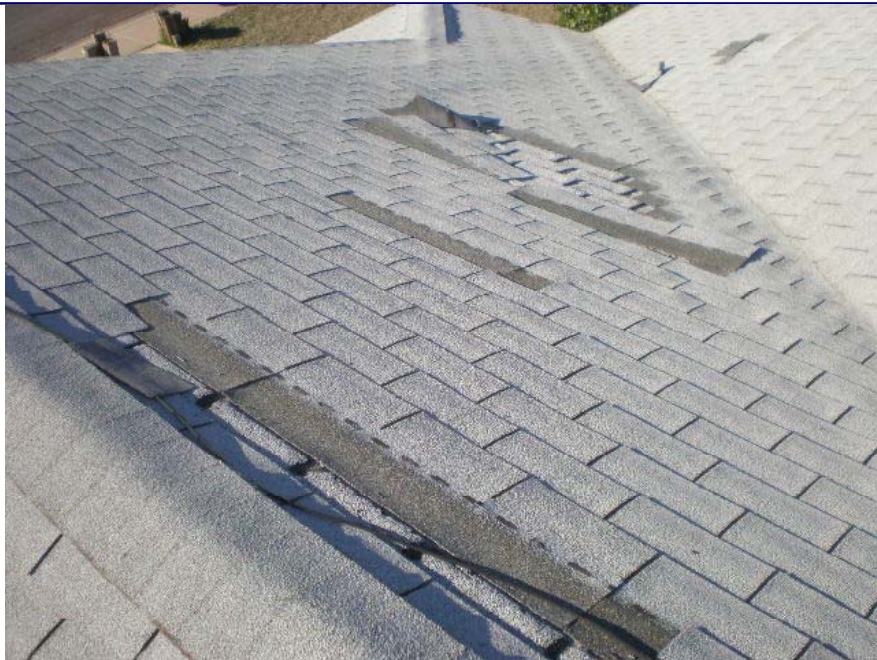
Picture 4

Roofing had at least two layers, unable to determine due to drip edge installation.* Main roof had damaged/ missing shingles, and was deteriorated, recommend full evaluation/ repairs be made by a qualified, licensed roofing contractor.(2)

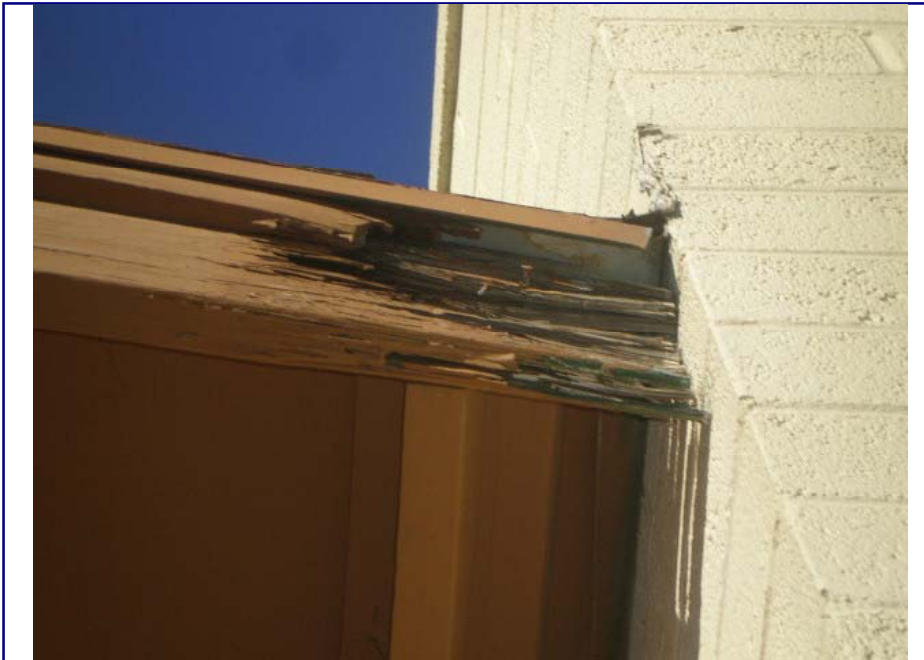
Picture 6

Damage/ deterioration noted at the fascia at the time of inspection.(2)
